Safety Assurance Team

Report

04/09/2025

Site visit at Manchester University

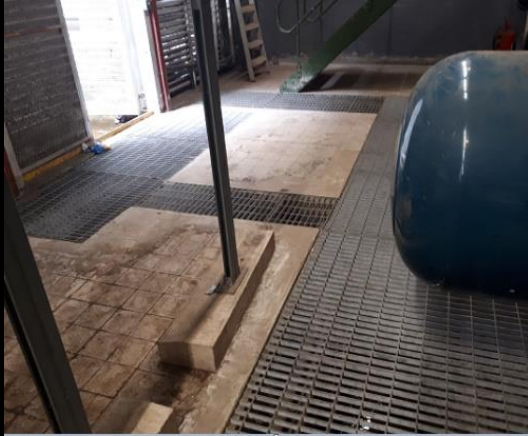
Figure 1: Evidence of Slips, Trips and Falls Finding

- **Slips, Trips, Falls**
 - Site had used concrete supports in the plant room to avoid drilling into the floor. However, this had created a number of trip hazards.
 - Reported this issue to site on the day so that they can apply some visible warning markings

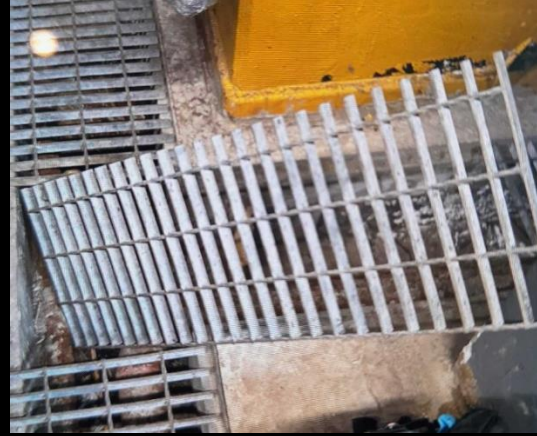
Figure 2: Evidence of Near Miss

- During our time on site, JBC Engineer reported a near miss in relation to a loose grate cover which he almost fell down. This was reported to site for rectification.

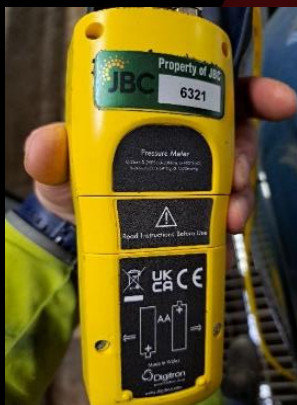
Figure 3: Evidence of manometer

- Manometer with no calibration sticker or certificate available – **Action: arrange to be swapped out.**
- Manual gas isolation valve installed on low gas inlet switch to the booster. Engineer had not spotted this. A warning notice was raised as this could bypass a safety interlock.
- No RAMS had been attached to the job by the office. However, the engineer had not looked for them. **Action: Call office to attach RAMS to the job.**
- A good overall visual check on all components of the burner as this was a minor service. Letby tests and tightness test carried out. Conversations were had as to where he had carried this out as the was a non-return valve inline. I explained how it should have been done.
