Safety Assurance Team

Report

Site visit at Elsham Mill

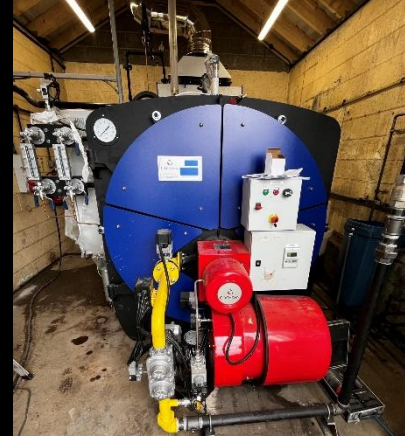
- **General Housekeeping**
 - Materials on the floor that could have been stored in a more suitable location.
 - Trailing cable in front of hot header – This was not raised as a near miss, it was picked up by the assurance team and corrected – Be mindful that this is identified on your DRA and the risk is controlled

- **DRA**
 - Although the DRA was completed, it did not identify materials stored on the floor as a hazard, it was evident that there were lots of materials on the floor with compromised space. – Be mindful to identify and manage accordingly to reduce the likelihood of an accident.

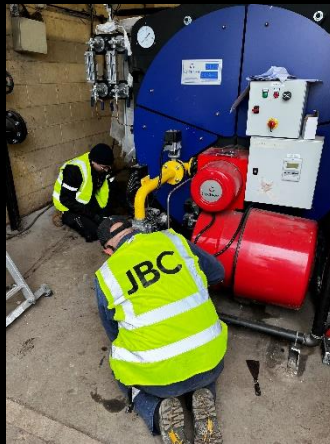
- **Boiler installation was not completed and commissioned, audit could not be carried out.**
 - All valves and install were positioned correctly as required, it was highlighted the need for correct LPG identification tape to be put on the pipework as required on completion of the install

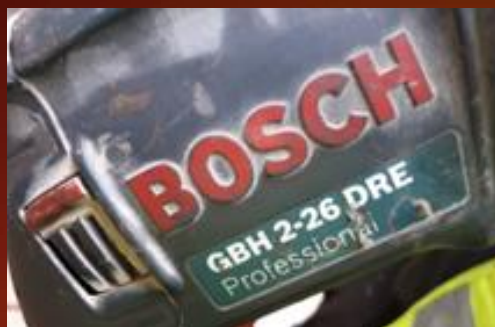
- **Power Tools – Incomplete asset register**
 - On the inspection we gathered all the makes and models of power tools, this will be used to complete accurate calculations of safe trigger times – The information will be uploaded into files on the tablets and toolbox talk rolled out

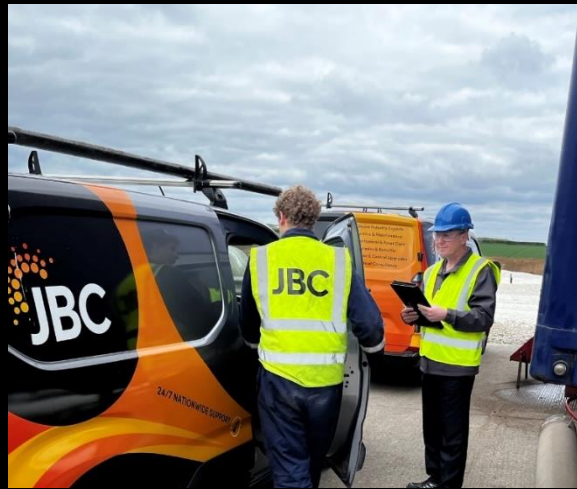
- **Signage for van**
 - A van had been carrying compressed air without the correct signage – Toolbox talk to be circulated to highlight signage requirements.
- **Positive Observation**
 - All vehicles on site had an in-date fire extinguisher
- **First aid kit**
 - First aid kit out of date – Check the date on your first aid kit contents when you complete your vehicle checks, if a new one if required, please inform H&S
